TEST REPORT

No. 388/13

ZIP-Bag / 5 pieces

Testing to determine the degree of protection IP Code X8 in accordance with
DIN EN 60529 : 2000-09 (VDE 0470-1)

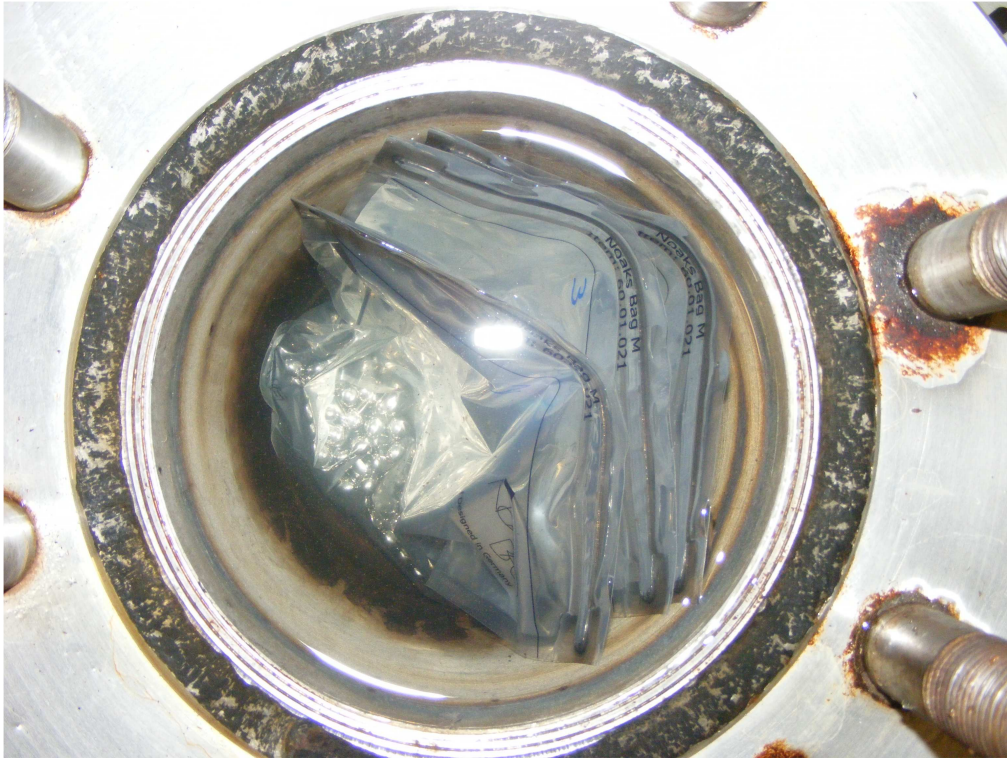
figure 1 position for IP Code X8 Test

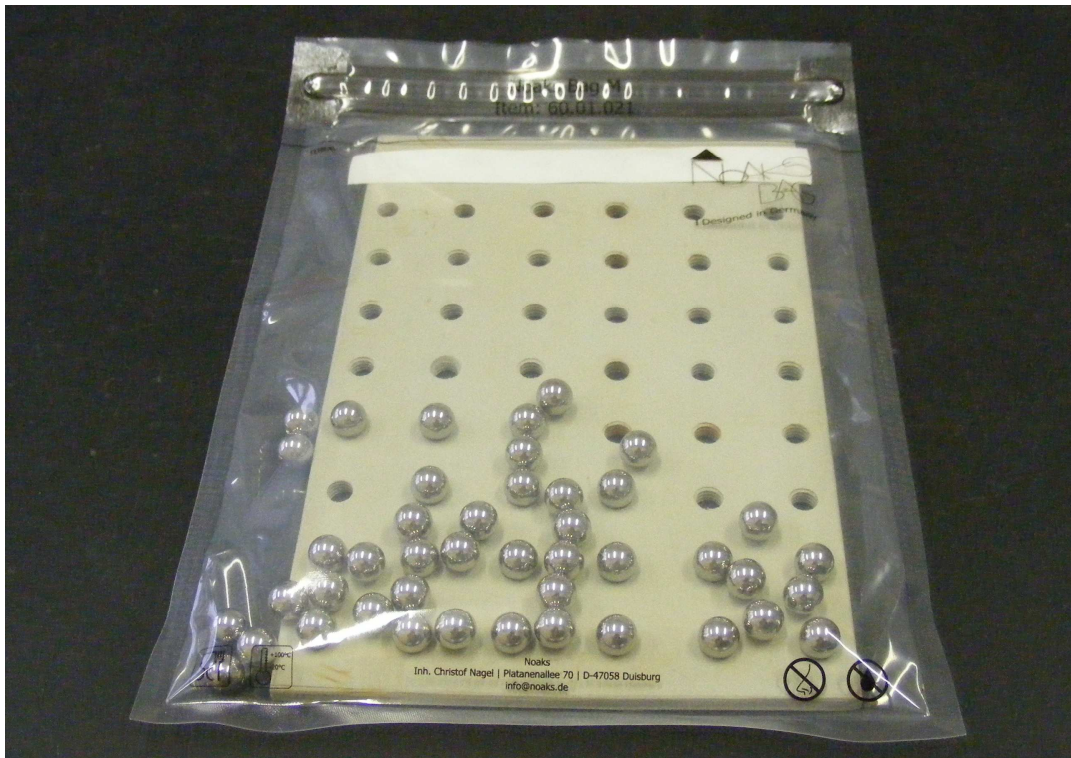
No water is visible inside the specimens.

Changes are not visible.

figure 2 specimen No. 5 after IP Code X8 Test, exemplary
